RE: SPIVEY LAKE DAM INSPECTION (3rd Quarter)
WA&A J.O. 4100700

WALDEN, ASHWORTH & ASSOCIATES, INC.
SPIVEY LAKE DAM VISUAL INSPECTION

Date: 09/03/21
Project: Spivey Lake Dam Visual Inspection
Project No.: 4100700
Project Location: Henry County, Georgia
Report By: Jason Rapplean, P.E., E.O.R.

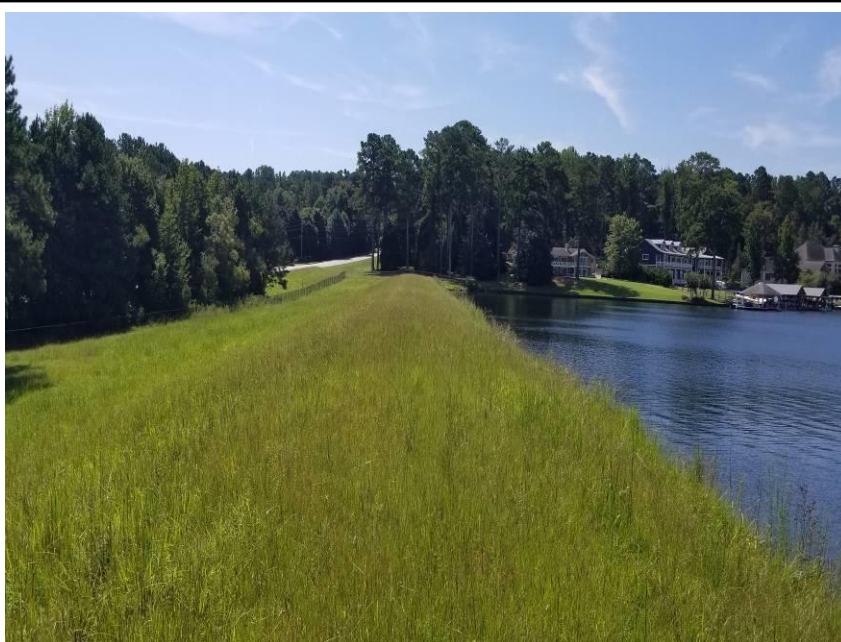
The horizontal and vertical alignment of the earth embankment appears to be generally good. The top of the dam is vegetated and appears to be in good condition with no cracking observed. The crest is covered with a good stand of maintained grass that needs to be mowed. No sinkholes or animal burrows were observed. The abutment contacts were good.

Crest of dam looking
towards right
abutment.

1. Mow the crest, embankments, and toe areas of the dam.
2. Continue to monitor the observation wells to look for any noticeable changes in seepage through the dam.
3. Remove any vegetation in the emergency spillway.
4. Continue to monitor seepage coming through the cracks in the concrete chute emergency spillway.

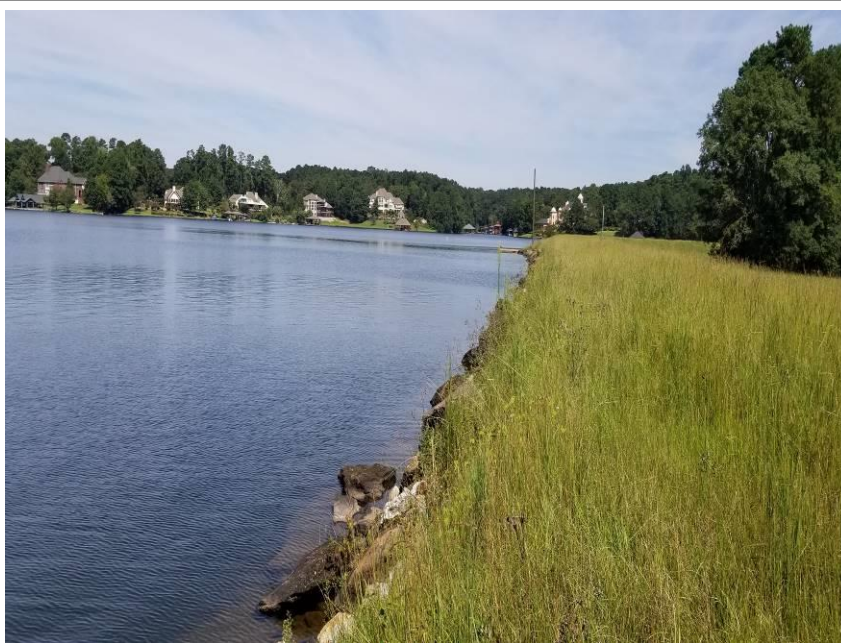
The upstream slope at the shoreline/boulders is steeper than 3:1. No unusual movement on the slope was observed since the previous inspection. No slides or sloughs were observed and the abutment contacts looked good. The steep upstream slope should continue to be monitored for any movement or erosion. The dam should be mowed to allow easier inspection of the dam crest, slopes, and toe.

Upstream slope of dam
with boulder shore
protection.

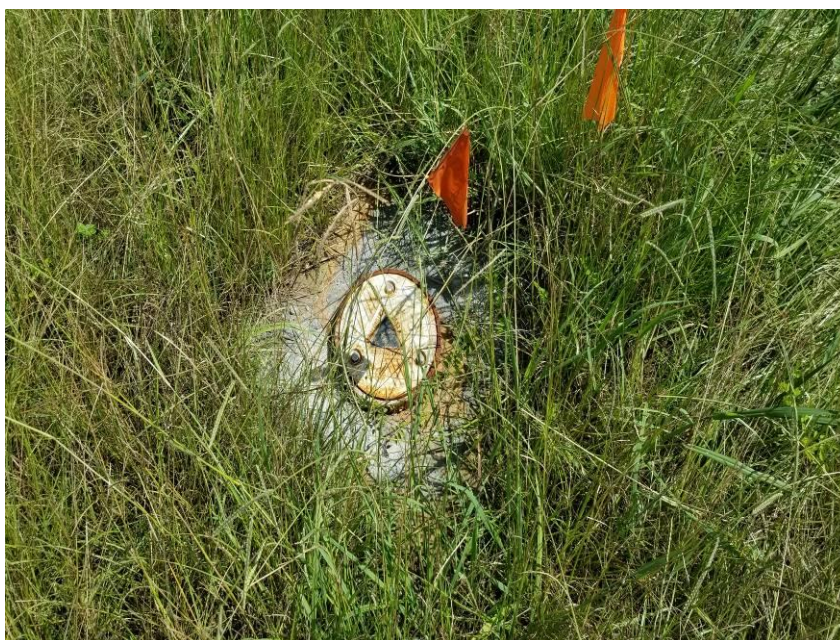
Observation well on
crest of dam.

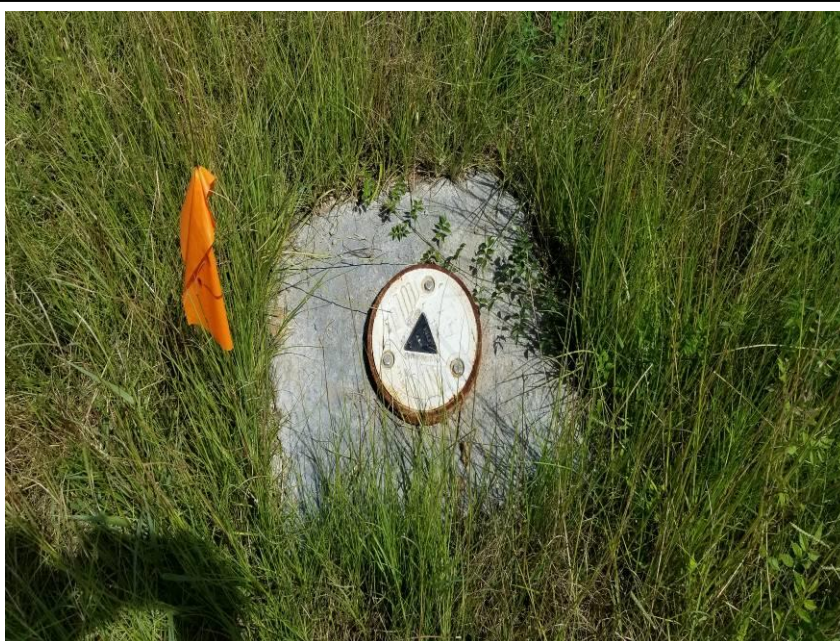
Observation well on
crest of dam.

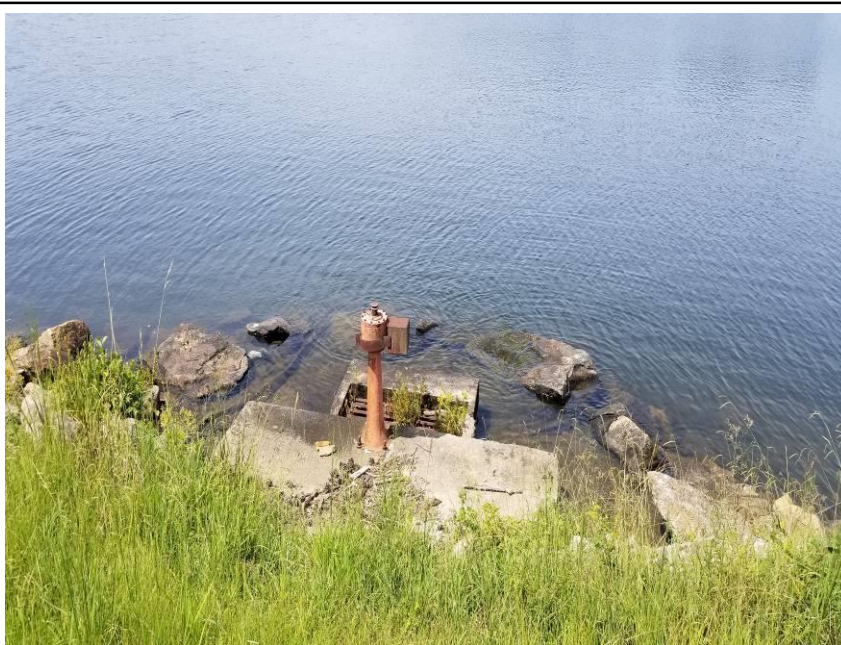
The drawdown outlet works structure is located near the center of the dam. No detailed observations were possible of the drawdown structure because it is below the grade and/or the water surface. No flow was observed from the outlet pipes. The low-level outlet pipes terminate at the downstream toe of the dam and discharge into a rip-rap lined channel. The channel appears to be providing adequate dissipation of the energy from flows discharging through the drain and seepage pipes.

Drawdown structure.

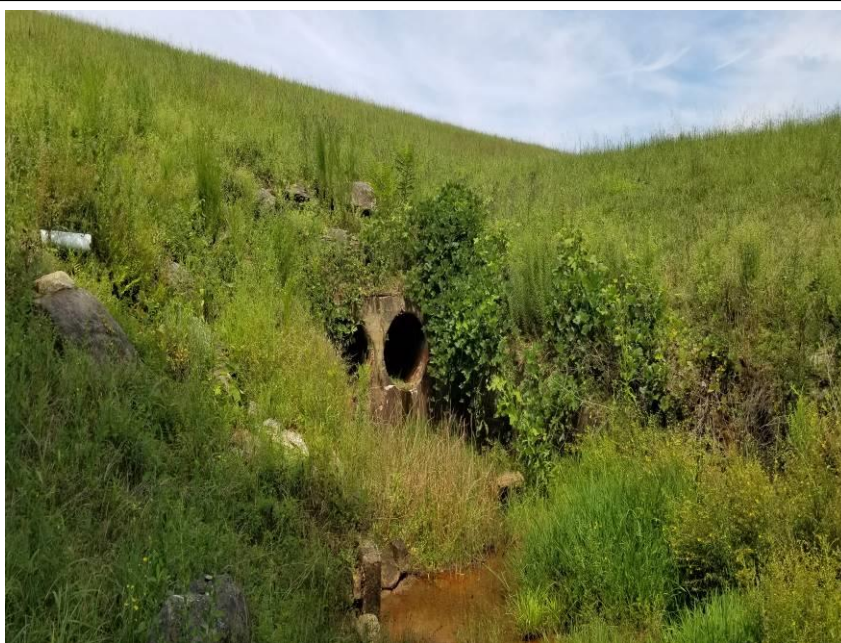
Drawdown/Low Level
Pipe outlet and toe
drain J.

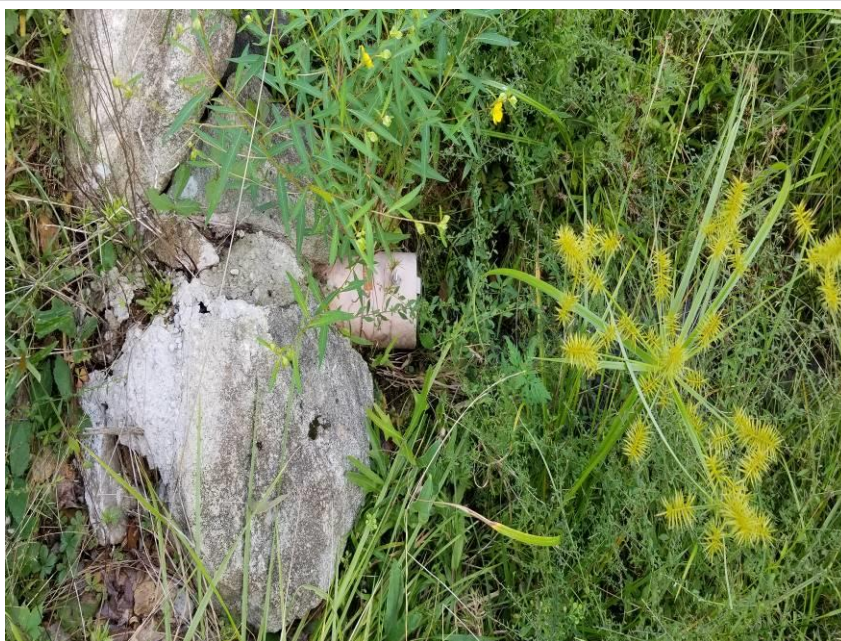
Toe drain K outlet near
low level drain.

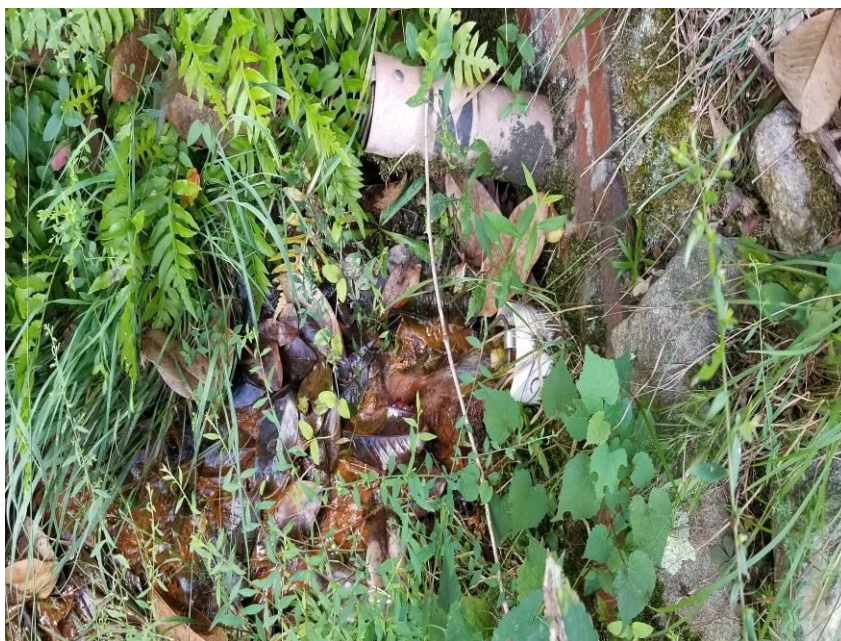
Toe drain L & M outlet
near low level drain.

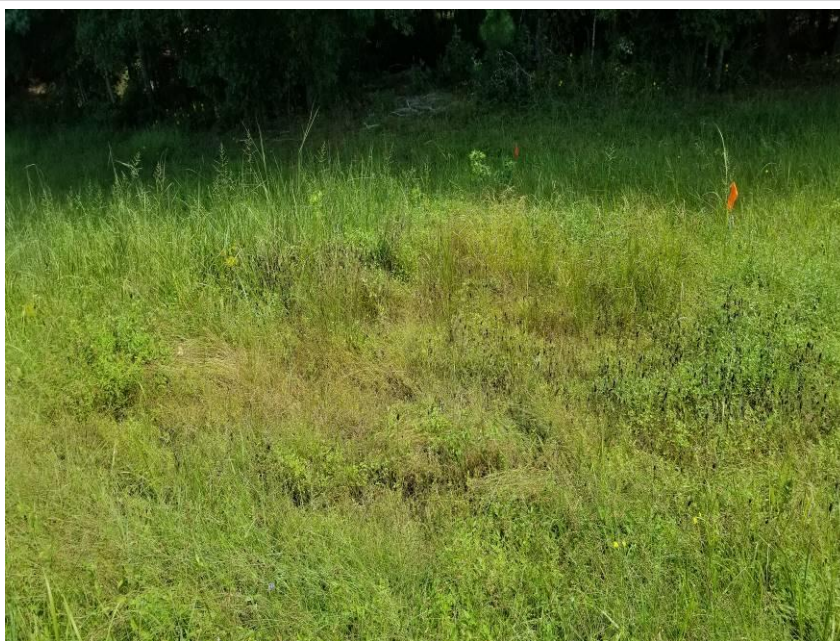
The downstream slope of the dam is covered with maintained vegetation that needs to be mowed. The slope appears to be approximately 3 horizontal on 1 vertical (3:1). No signs of sloughing or sinkholes were observed. The wet area which was observed to the right of the low-level drain outlet approximately 20 feet up the slope near the toe of the dam continues to be wet and soft indicating seepage. Monitoring wells have been installed at the crest of the dam and around the seepage area to monitor this area. This area should continue to be monitored closely for any significant changes. See the attached well readings for additional information.

Seepage area near toe of dam.

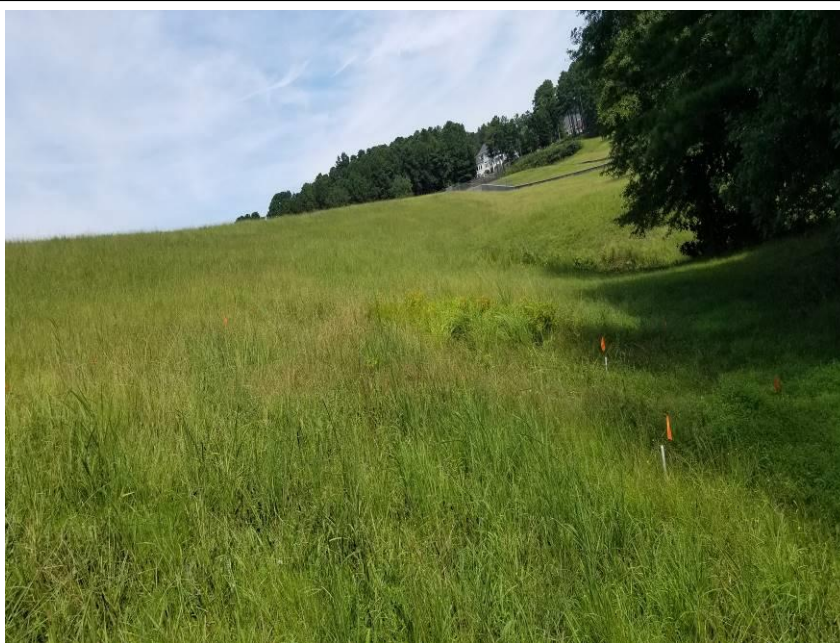
Seepage area near toe of dam. Note observation wells in the area.

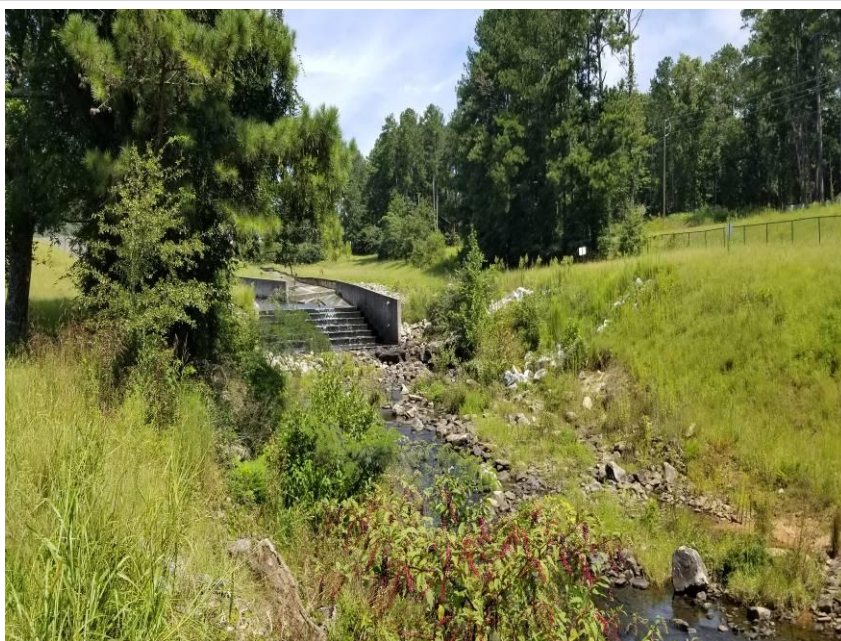
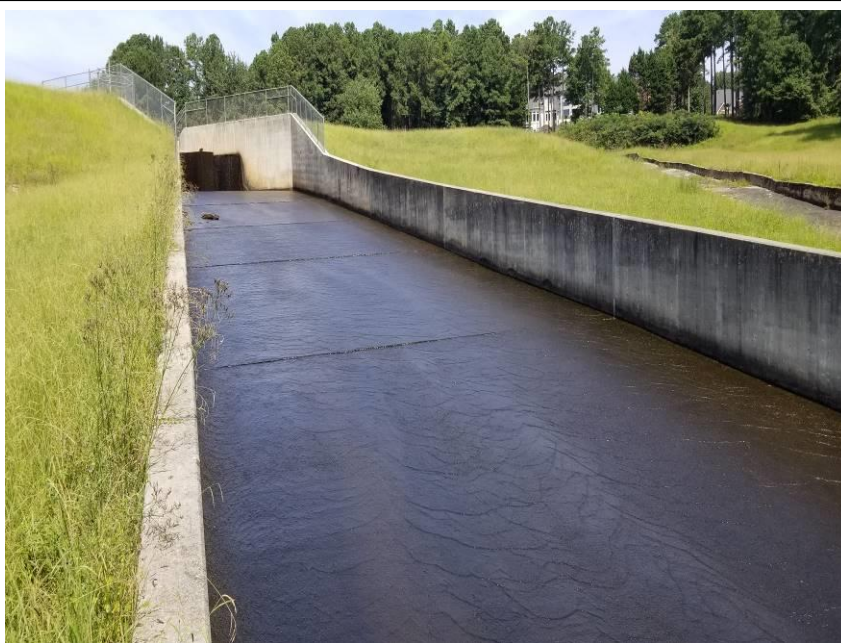
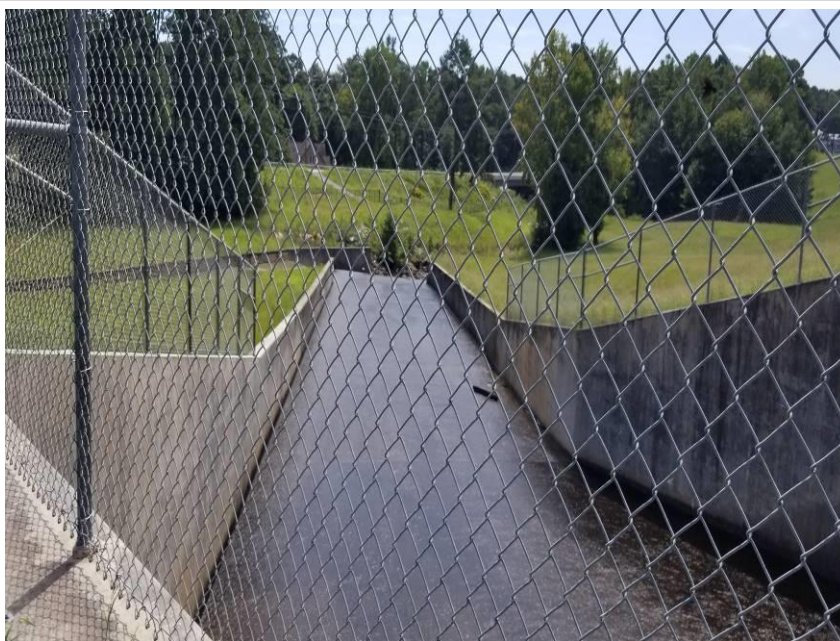
The primary spillway structure appeared to be in good condition. The concrete chute and stepped stilling basin empty into a riprap lined channel. The channel is free from encroaching vegetation and appears to be providing adequate dissipation of the energy from flows discharging through the chute and stilling basin. The primary spillway had flow making it difficult to visually inspect much of the spillway slab closely.

Principal spillway.
Concrete labyrinth
spillway and chute.

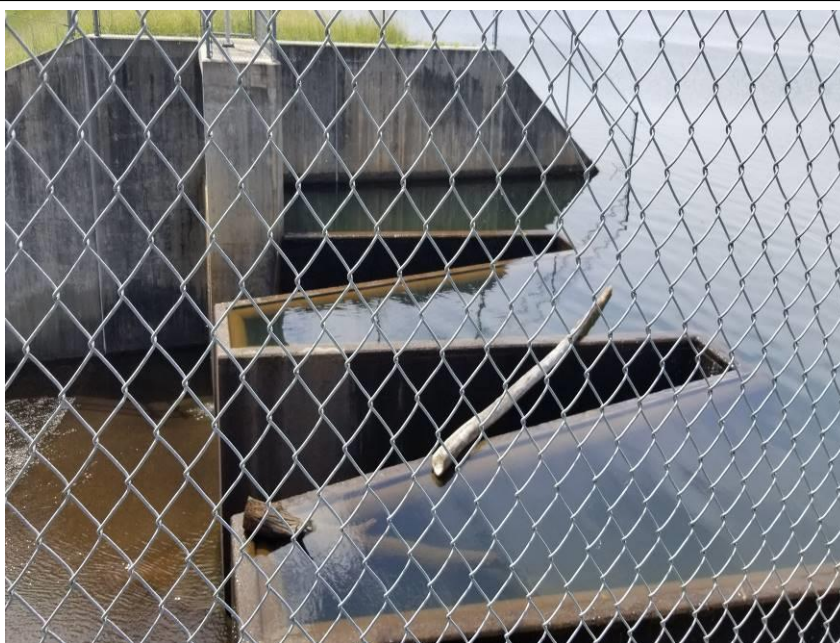
Labyrinth weir walls..

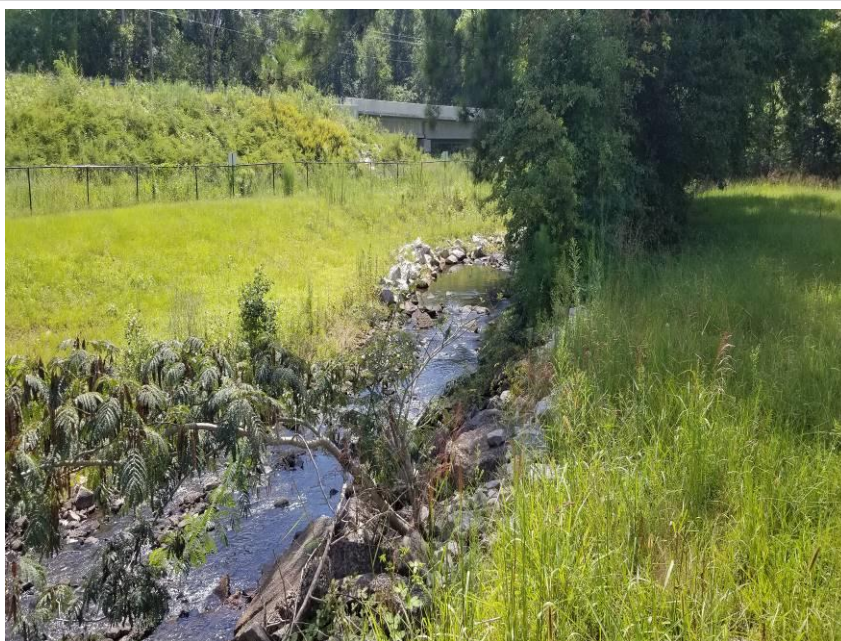
Downstream exit
channel.

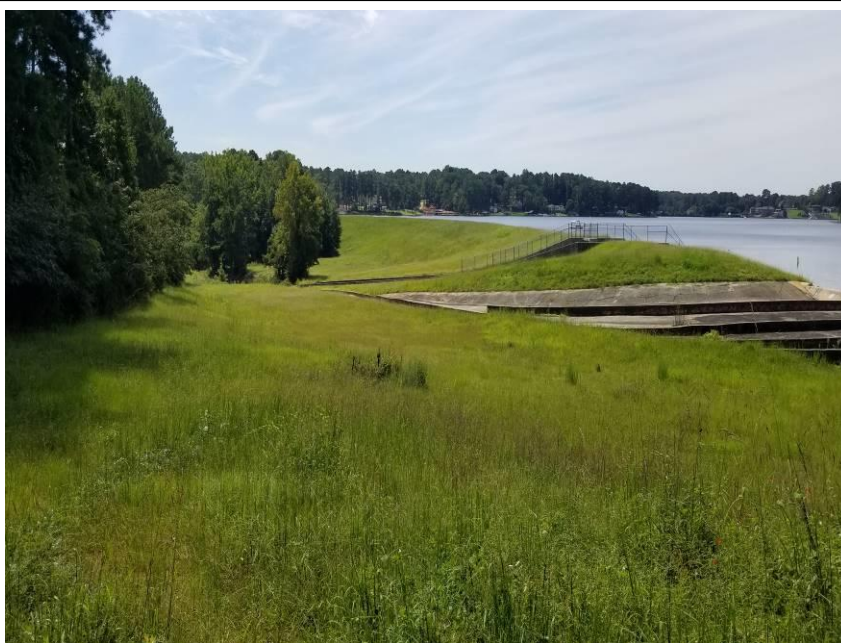
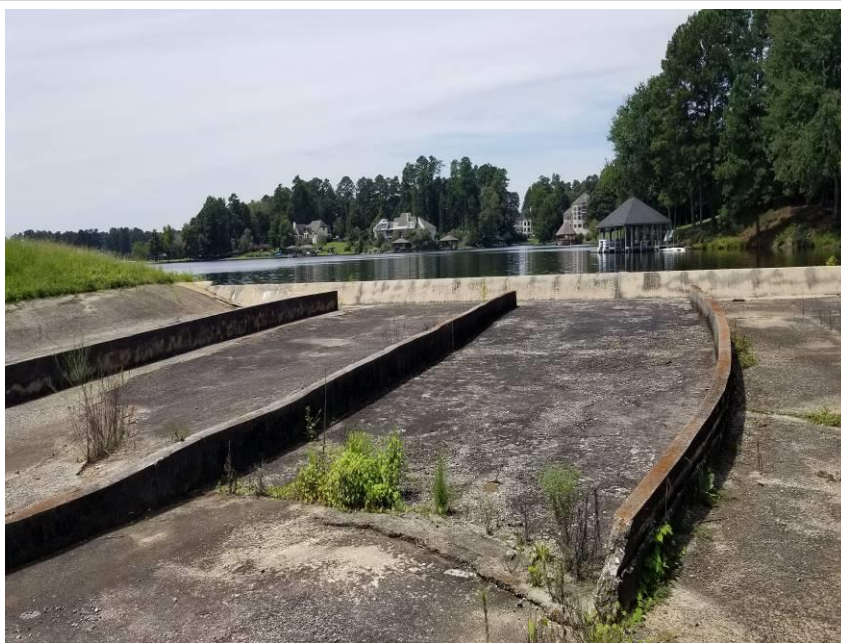
The secondary or emergency spillway consists of a concrete weir and chute channel located in the left abutment. The spillway appears to be generally in good condition with some minor cracking. The approach is unobstructed. Removal of any vegetation should continually be a part of the maintenance of the dam. There continues to be some possible seepage coming through some of the cracks in the spillway. There was no change since the previous inspection. These areas need to continue to be monitored. No evidence of frequent activation of this spillway was observed.

Concrete emergency
spillway chute,
downstream
embankment on left
side of dam.

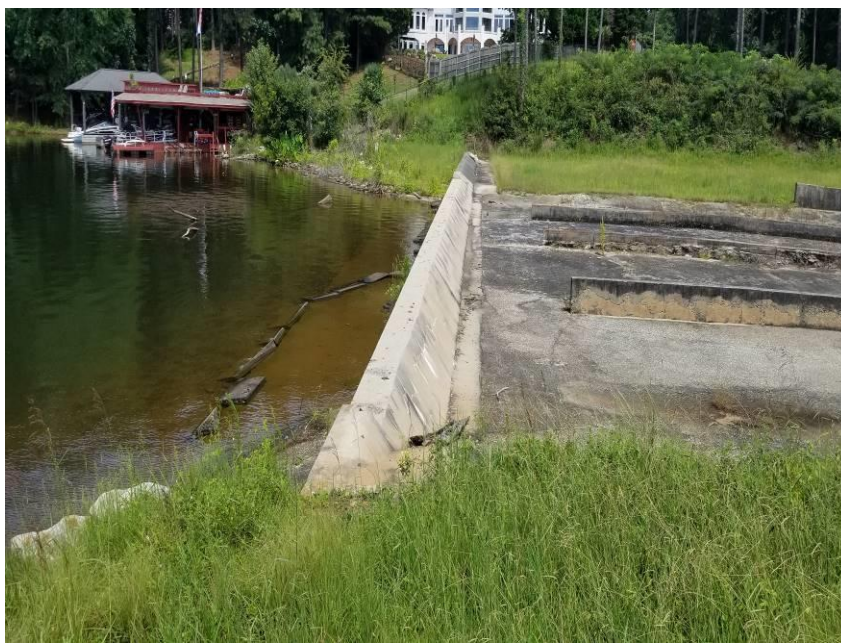
Concrete emergency spillway chute weir wall.

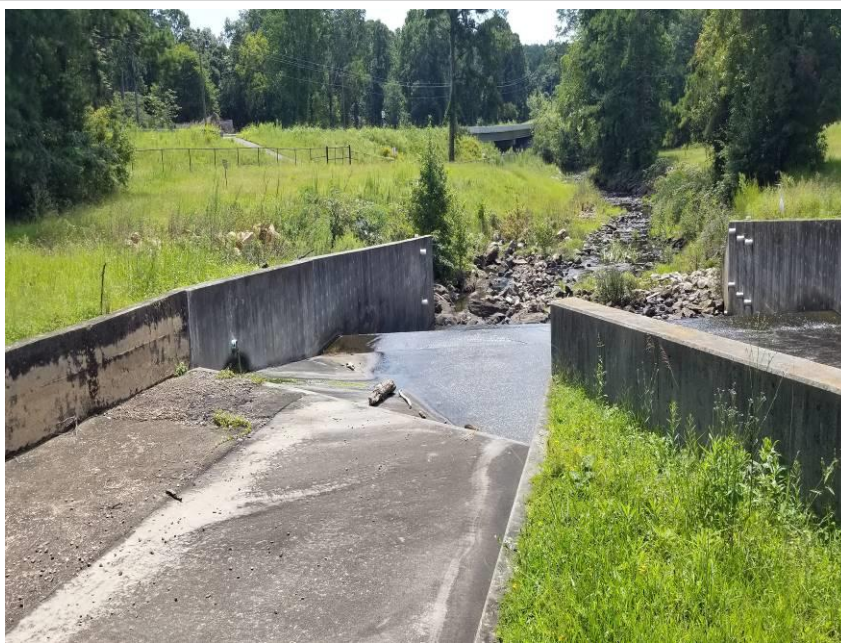
Concrete emergency
spillway chute outlet.

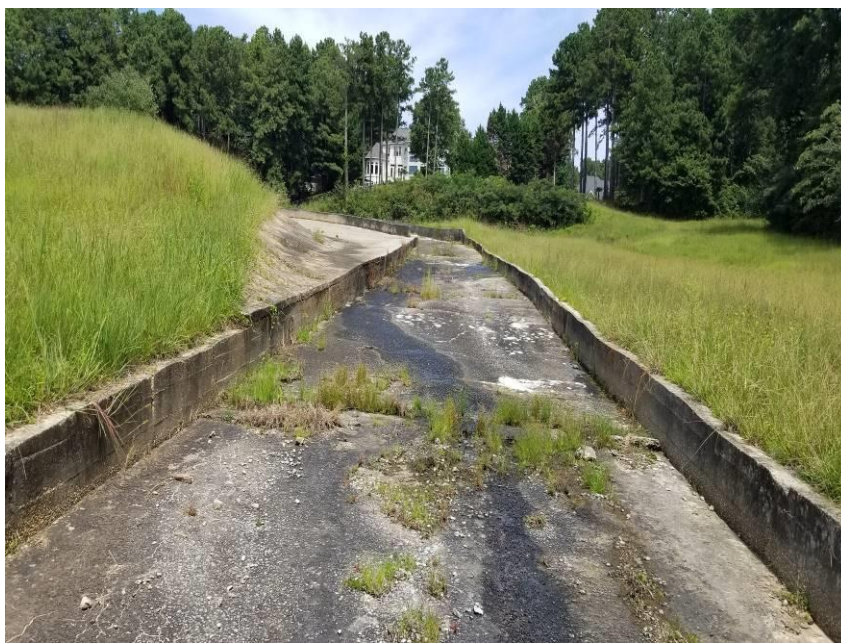
Concrete emergency
spillway chute,
downstream
embankment on left
side of dam. Note
seepage at cracks.
