RE: SPIVEY LAKE DAM INSPECTION (2nd Quarter)
WA&A J.O. 4300300

WALDEN, ASHWORTH & ASSOCIATES, INC.
SPIVEY LAKE DAM VISUAL INSPECTION

Date: 06/09/23
Project: Spivey Lake Dam Visual Inspection
Project No.: 4300300
Project Location: Henry County, Georgia
Report By: Jason Rapplean, P.E., E.O.R.

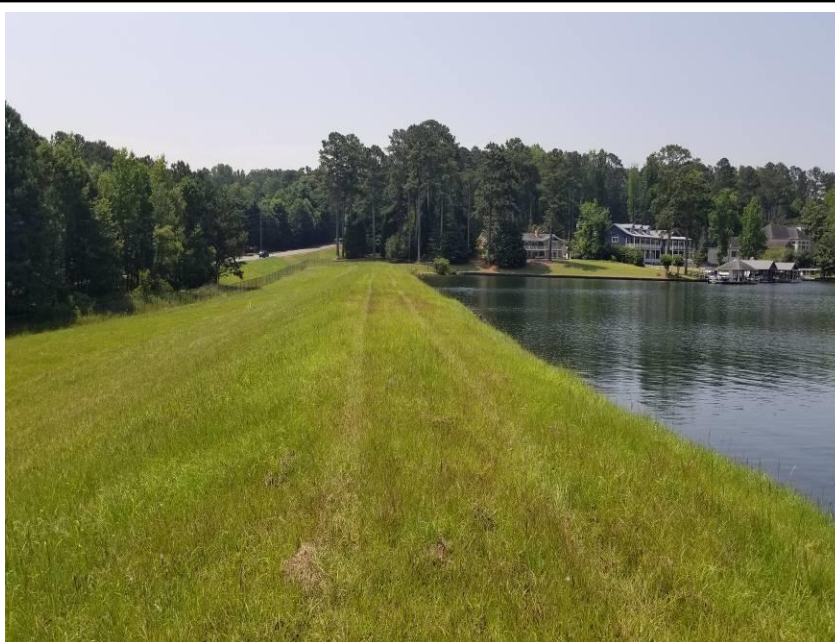
The horizontal and vertical alignment of the earth embankment appears to be generally good. The top of the dam is vegetated and appears to be in good condition with no

cracking observed. The crest is covered with a good stand of maintained grass. No sinkholes were observed. The abutment contacts were good.

Crest of dam looking
towards right
abutment.

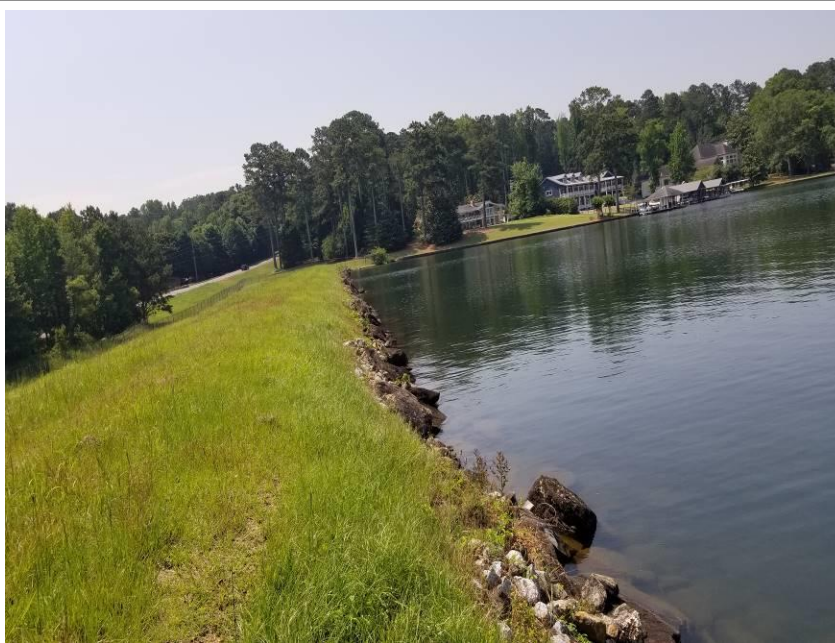
The lake was at normal pool at the time of our inspection. Our ability to inspect the upstream slope was limited due to water in the reservoir. The portion of the slope that is visible above the water line is covered with adequate vegetation that appears to be in good condition. Large boulders and rip rap were observed along the normal pool shoreline to provide protection to the embankment from wave action when the reservoir is at normal pool.

The upstream slope at the shoreline/boulders is steeper than 3:1. No unusual movement on the slope was observed since the previous inspection. No slides or sloughs were observed and the abutment contacts looked good. The steep upstream slope should continue to be monitored for any movement or erosion. An animal burrow was observed at the top of the rip rap and boulders on the right side of the dam approximately 300 feet to the left of the right abutment. This area needs filled in and repaired. There was some small trees/brush located along the top of the rip rap wave protection near the concrete labyrinth spillway. These areas should be cleared.

Upstream slope of dam
with boulder shore
protection.

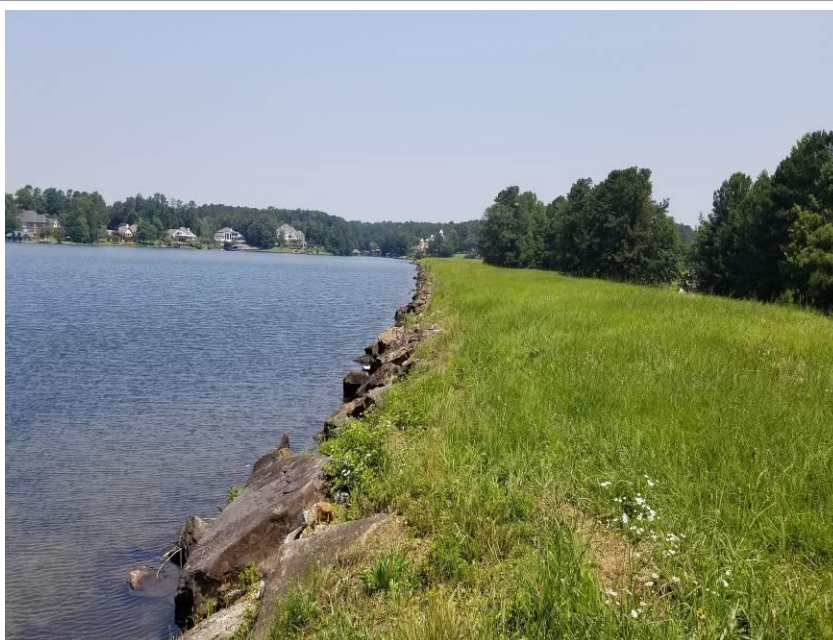
Upstream slope of dam with boulder shore protection.

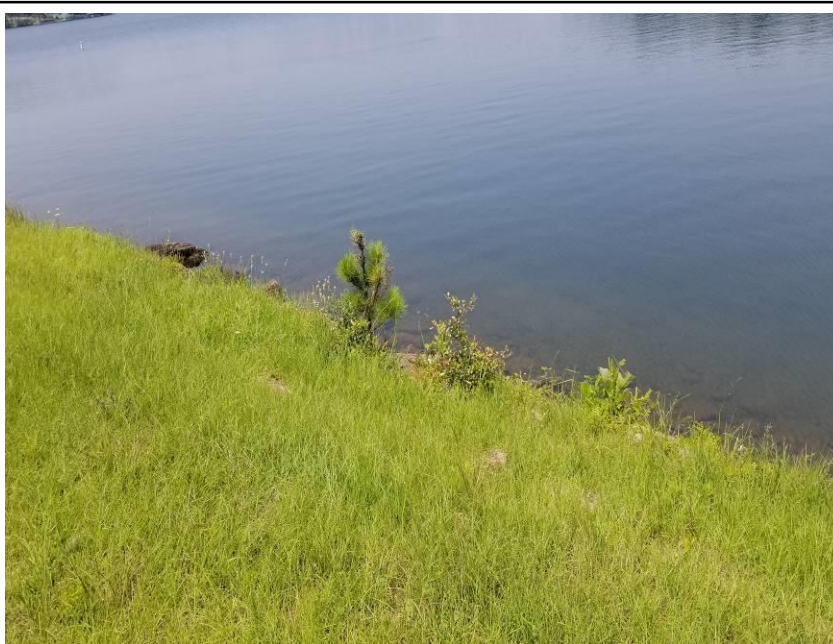
Upstream slope of dam. Note trees and brush beginning to grow along rip rap wave protection.

- ☐ 3. Are there any trees or other inappropriate or excessive vegetation on the slope? Yes ☒ No _____
If yes, describe (type of vegetation, size, location, etc.)/Corrective Action: minor trees Near Spillway

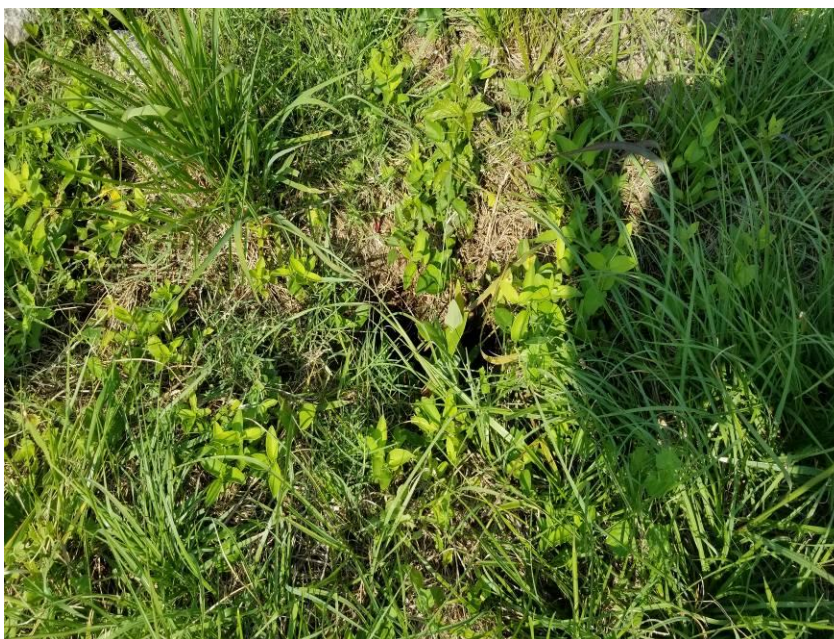
Animal burrow at top of rip rap wave protection.

- ☐ 4. Are there any depressions, bulges, ruts or holes (such as animal burrows) on the slope? Yes ☒ No _____
If yes, describe (size, location, etc.)/Corrective Action: 300 ft left of right abutment @ top of rocks

1. Continue to monitor the observation wells to look for any noticeable changes in seepage through the dam.
2. Remove any vegetation in the emergency spillway.
3. Continue to monitor seepage coming through the cracks in the concrete chute emergency spillway.
4. Repair animal burrow located at the top of the rip rap wave protection located approximately 300 feet to the left of the right abutment of the dam.
5. Clear away any trees/brush along the rip rap wave protection.
6. Mow the downstream slope and left side of the dam.
7. Clear any encroaching vegetation from around the toe drain outlets.

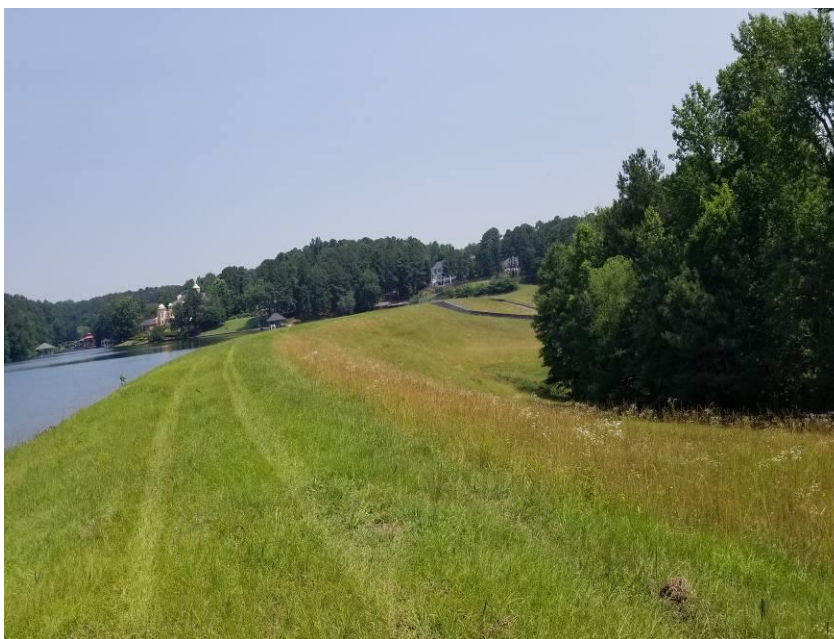
The downstream slope of the dam is covered with maintained vegetation. During this inspection the grass had grown to waist level and needs to be cut. The slope appears to be approximately 3 horizontal on 1 vertical (3:1). No signs of sloughing or sinkholes were observed. The wet area which was observed to the right of the low-level drain outlet approximately 20 feet up the slope near the toe of the dam continues to be wet and soft indicating seepage. There was no significant change in the area since the previous inspection. Monitoring wells have been installed at the crest of the dam to monitor the seepage levels in this area. This area should continue to be monitored closely for any significant changes. Measurements were taken of the permanent monitoring wells. See the attached well readings for additional information.

Crest and downstream embankment looking towards the left abutment. Note overgrown grass that needs mowed.

- ☐ 1. How would you describe the vegetation on the downstream slope? (Check all that apply)
Recently Mowed ☐ Overgrown ☒ Good Cover ☒ Sparse ☐
Other/Corrective Action (describe): Needs mowed

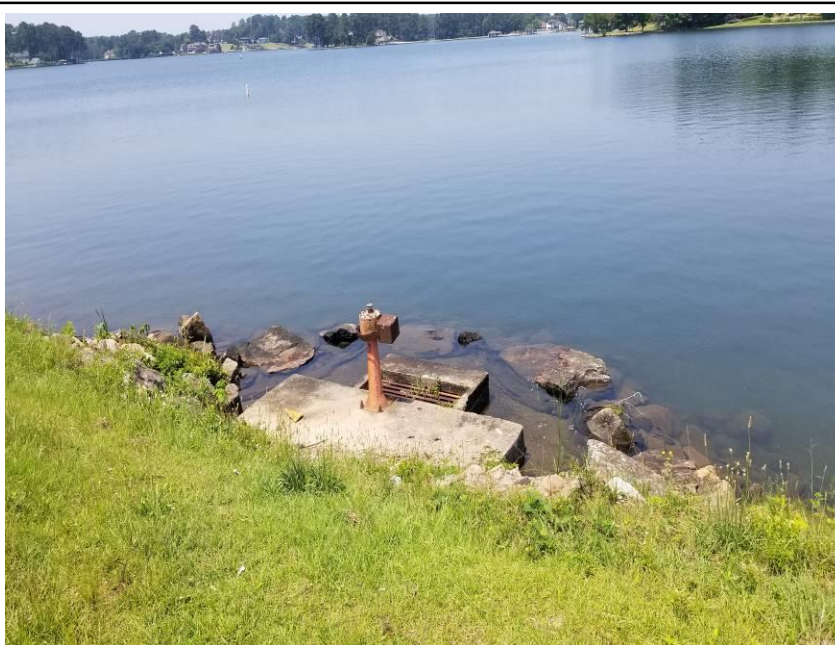
The drawdown outlet works structure is located near the center of the dam. No detailed observations were possible of the drawdown structure because it is below the grade and/or the water surface. No flow was observed from the outlet pipes. The low-level outlet pipes terminate at the downstream toe of the dam and discharge into a rip-rap lined channel. The channel appears to be providing adequate dissipation of the energy from flows discharging through the drain and seepage pipes.

Drawdown structure.

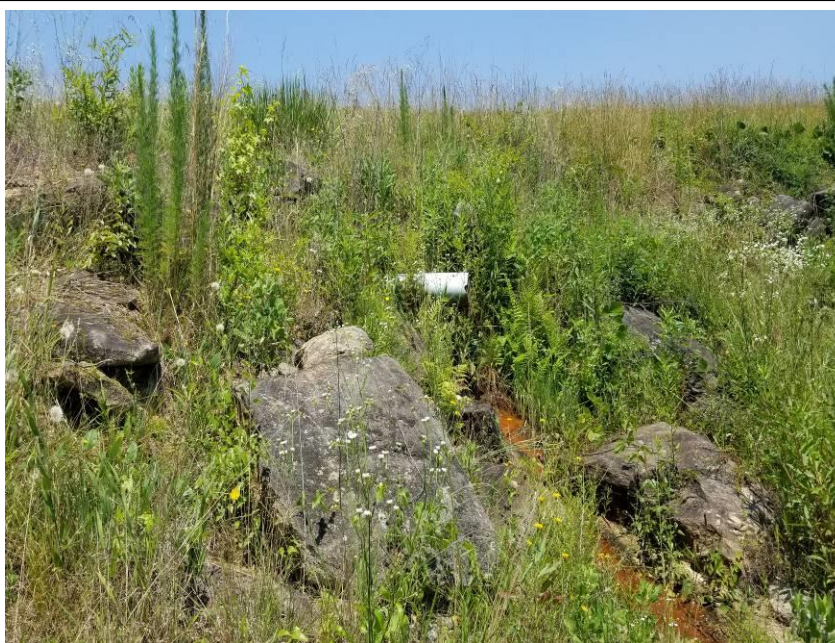
Drawdown/Low Level
Pipe outlet and toe
drain J.

Designation/Location of Drain	Flow Rate	Flow Rate in GPM*	Turbidity of Flow (describe - clear, muddy, etc.)
J	905	0.67	clear
K	trickle	trickle	"
L	105	0	"
M	trickle	trickle	"

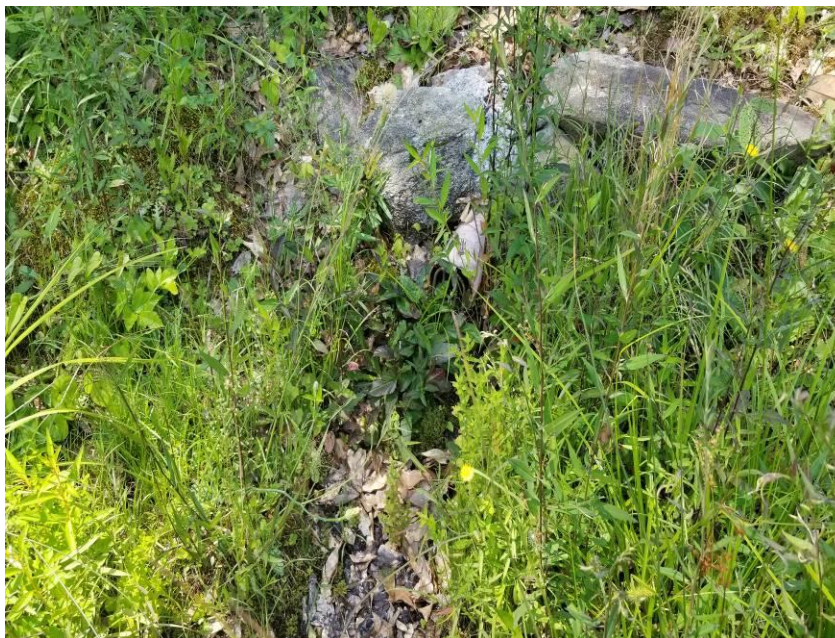
Seepage drains are located at the downstream end of the dam and on the right side of the drawdown outlet. The seepage drains had clear unobstructed flow. However, vegetation has begun to encroach on the outlets and these areas need cleared. Flow measurements were taken from the drains. There are also seepage drains along the primary labyrinth weir spillway on the downstream side of the dam. These drains are to collect any seepage near the primary spillway chute. These drain outlets had no or minimal flow.

Toe drain K outlet near low level drain. Note vegetation beginning to encroach on outlet.

clear out vegetation

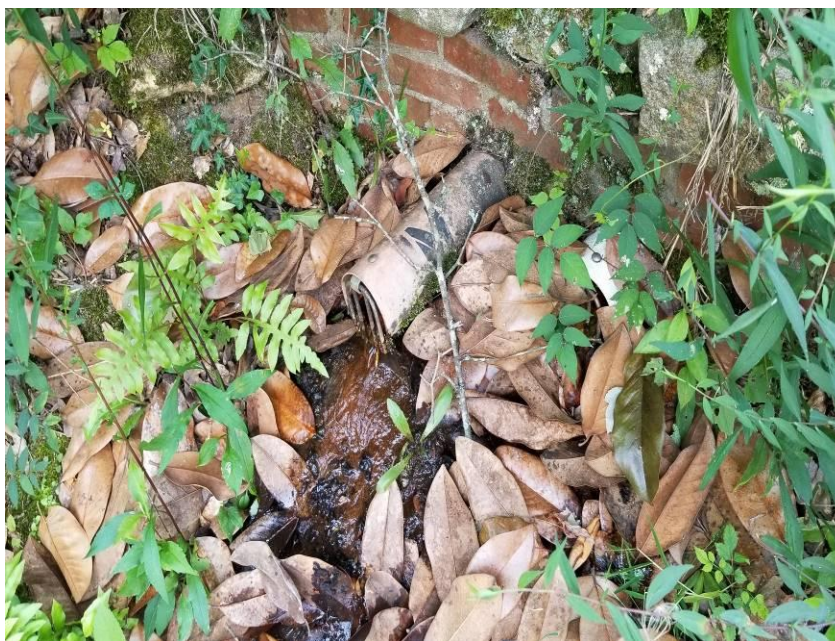
Toe drain L & M outlet near low level drain. Note vegetation beginning to encroach on outlet.

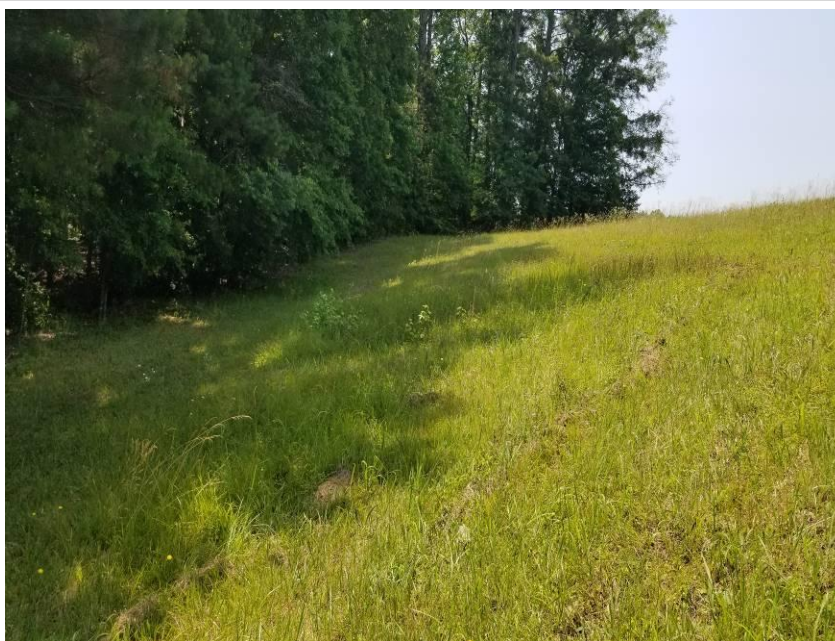
Seepage area near toe of dam. Note the downstream embankment needs mowed.

- ☐ 6. Are there any wet areas or areas of hydrophilic (lush, water-loving) vegetation? Yes ☒ No ☐
If yes, describe (size of area, location, etc.)/Corrective Action: Near toe no change

- ☐ 7. Do any wet areas indicate seepage through the dam (such as rust-colored, stained water)? Yes ☒ No ☐ N/A ☐
If yes, describe (for example, new area of seepage, no change from past observations, size of area, location) /Corrective Action: Near toe no change

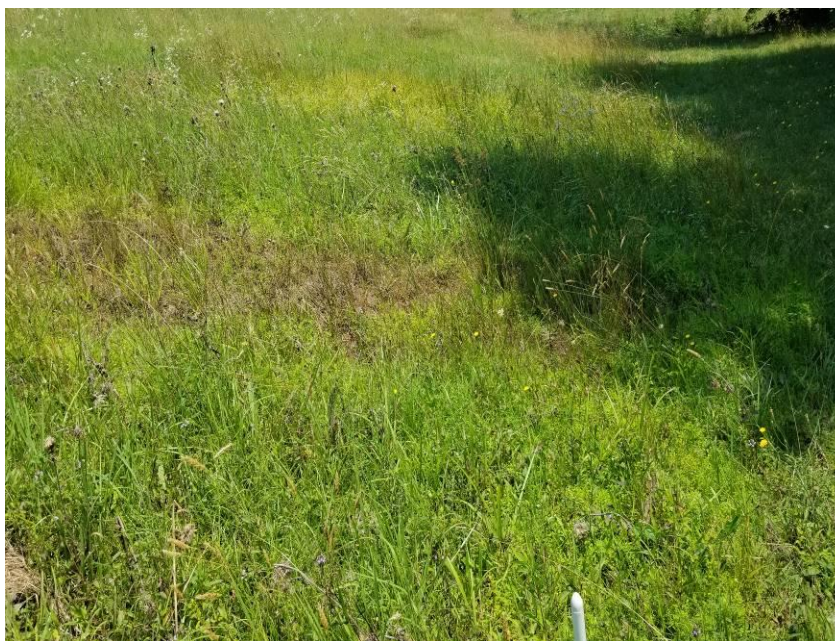
Seepage area near toe of dam. Note observation wells in the area. Note the downstream embankment needs mowed.

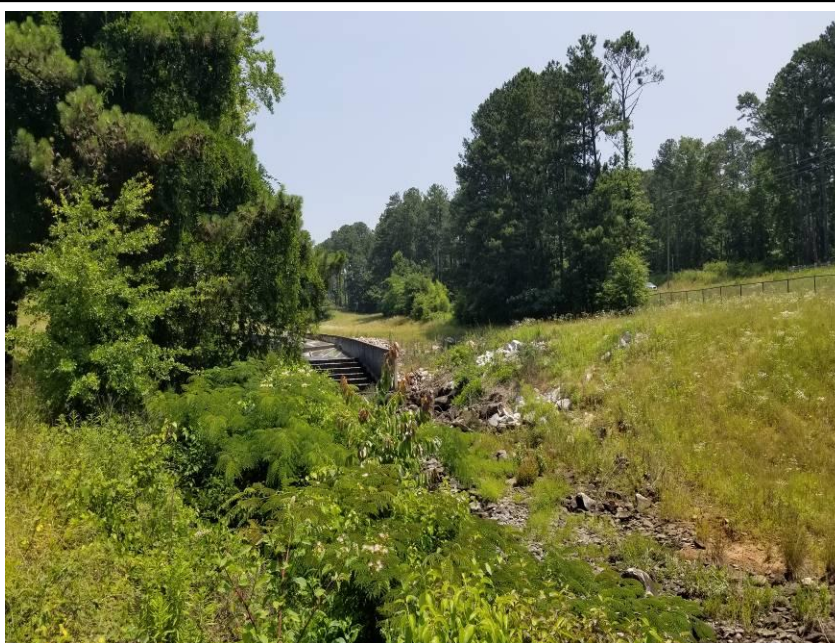
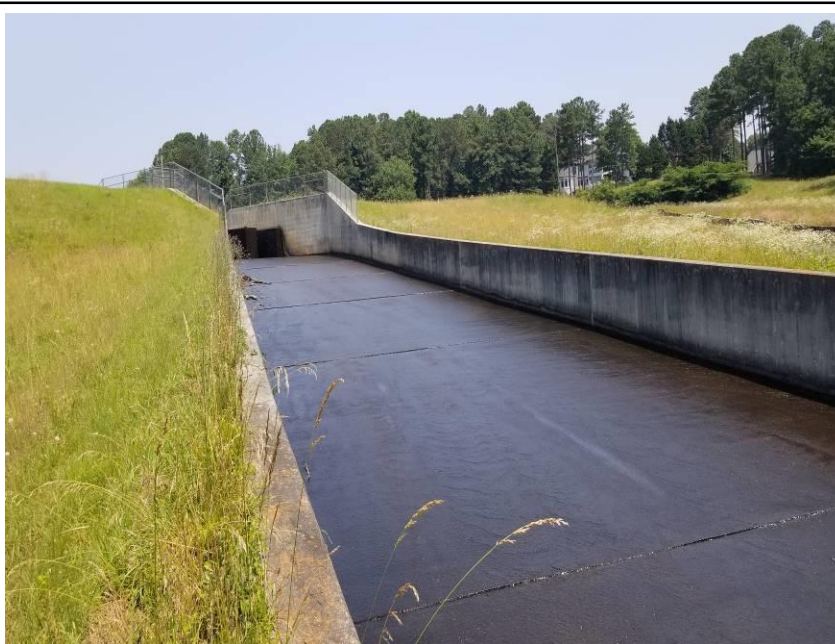
The primary spillway structure appeared to be in good condition. The concrete chute and stepped stilling basin empty into a riprap lined channel. The channel is free from encroaching vegetation and appears to be providing adequate dissipation of the energy from flows discharging through the chute and stilling basin. The primary spillway had flow making it difficult to visually inspect much of the spillway slab closely.

Principal spillway.
Concrete labyrinth
spillway and chute.

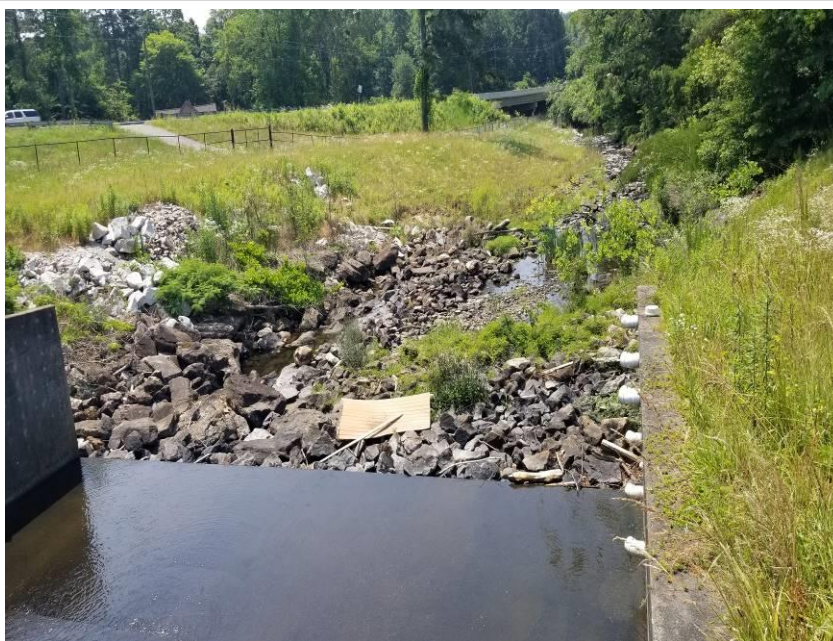
Principal and
emergency spillway.
Concrete chute outlet.

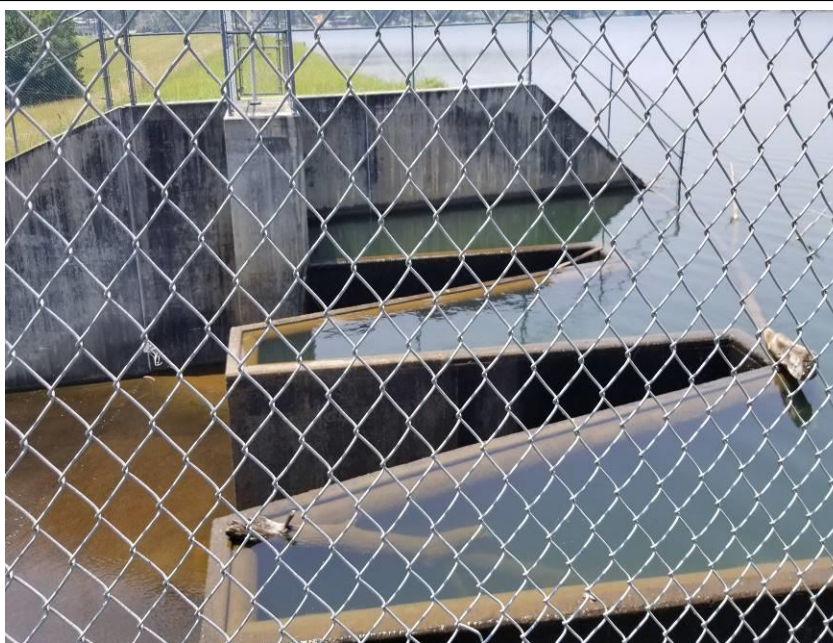
Labyrinth weir walls..

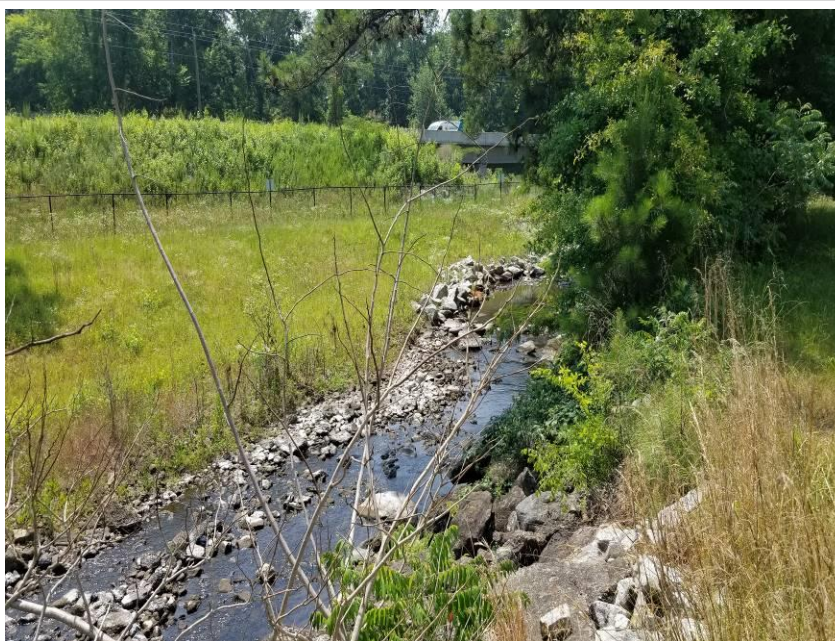
Downstream exit
channel.

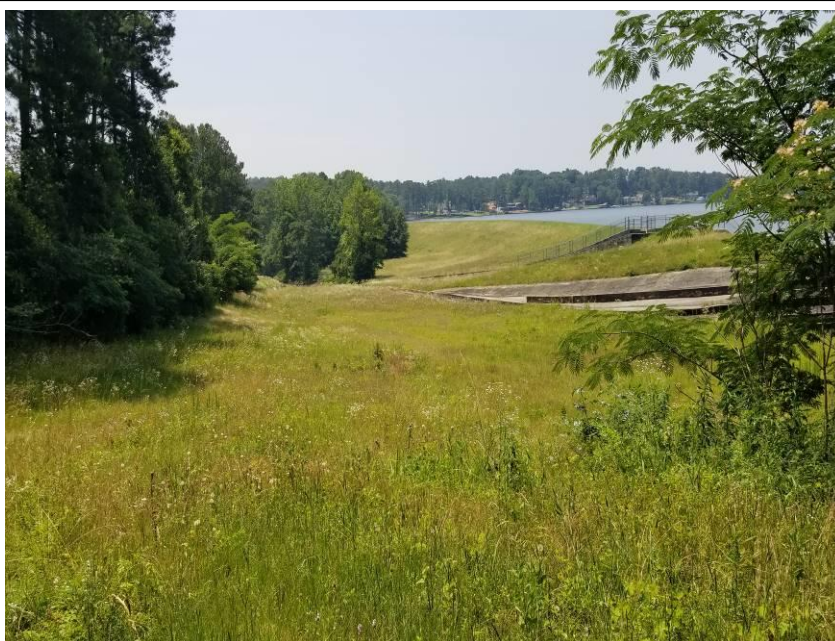
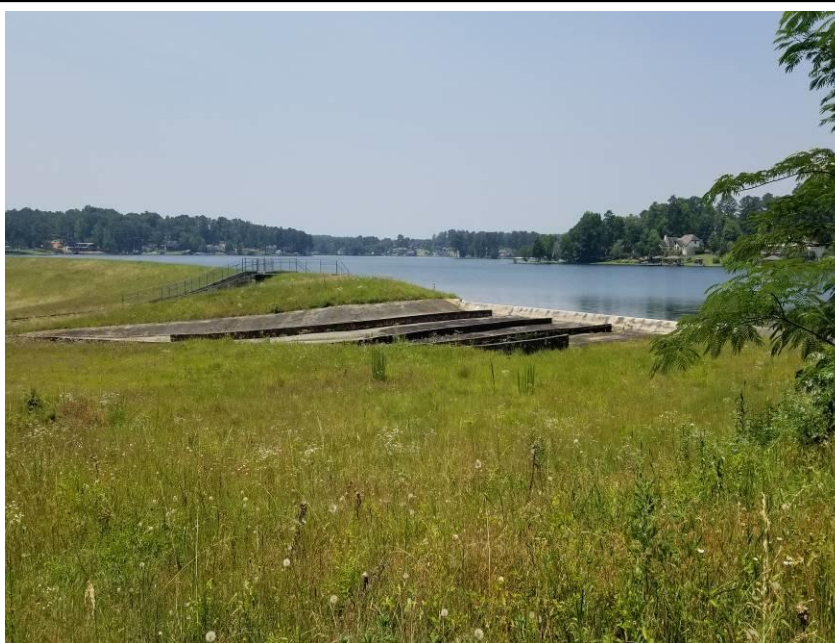
The secondary or emergency spillway consists of a concrete weir and chute channel located in the left abutment. The spillway appears to be generally in good condition with some minor cracking. The approach is unobstructed. Removal of any vegetation should

Concrete emergency
spillway chute,
downstream
embankment on left
side of dam.

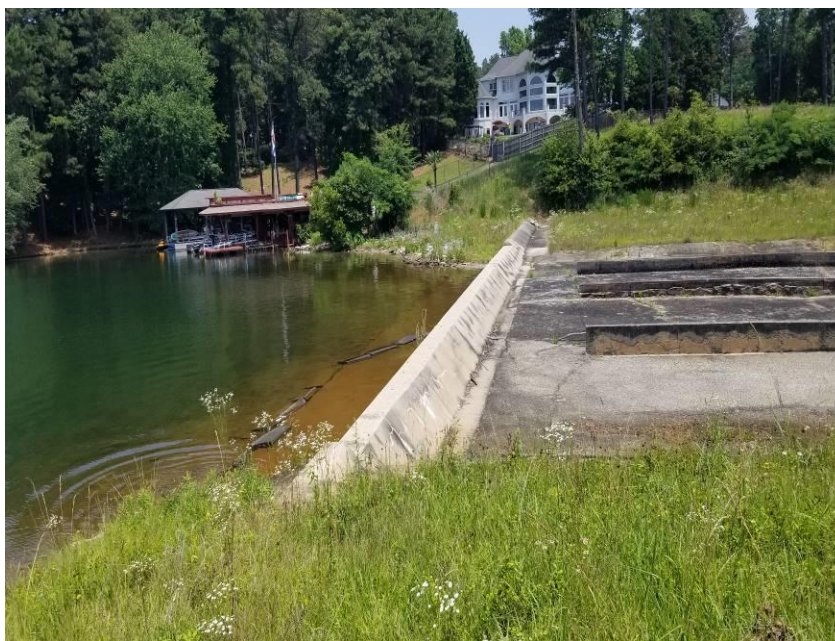
Concrete emergency
spillway chute weir
wall.

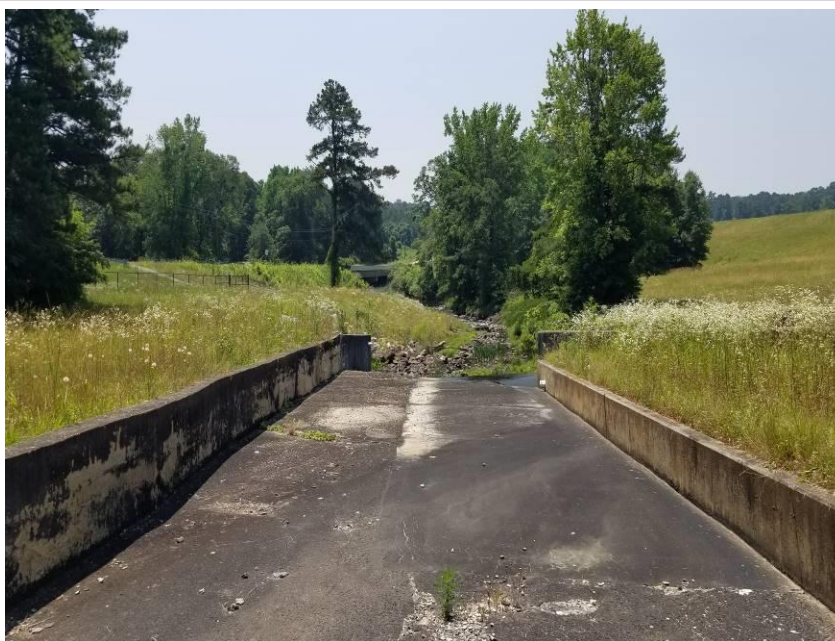
Concrete emergency
spillway chute outlet.

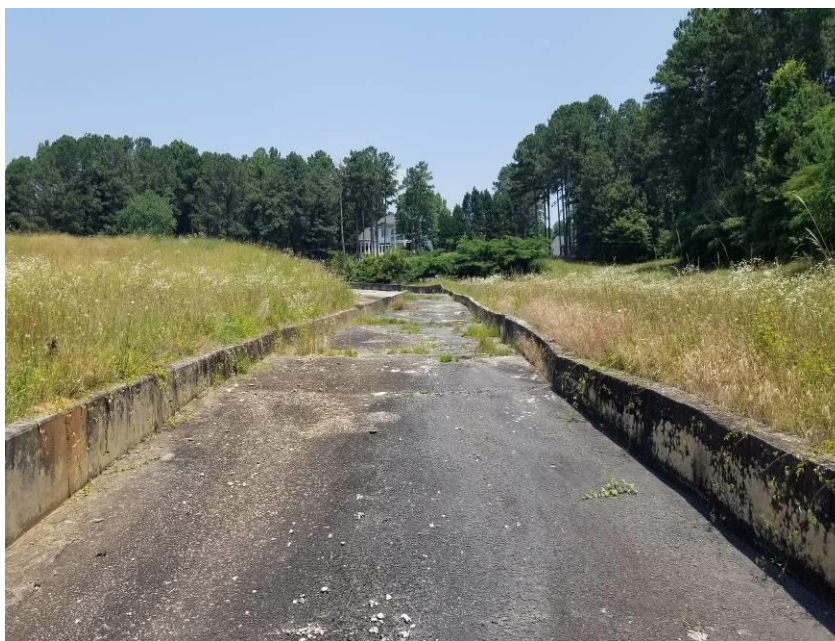
continually be a part of the maintenance of the dam. There continues to be some possible seepage coming through some of the cracks in the spillway. There was no change since the previous inspection. These areas need to continue to be monitored. No evidence of frequent activation of this spillway was observed.

Concrete emergency
spillway chute,
downstream
embankment on left
side of dam. Note
seepage at cracks.

If yes, describe (width of crack or hole, location, etc.) /Corrective Action: minor cracks

No change
