RE: SPIVEY LAKE DAM INSPECTION (3rd Quarter)
WA&A J.O. 4100700

WALDEN, ASHWORTH & ASSOCIATES, INC.
SPIVEY LAKE DAM VISUAL INSPECTION

Date: 09/03/21
Project: Spivey Lake Dam Visual Inspection
Project No.: 4100700
Project Location: Henry County, Georgia
Report By: Jason Rapplean, P.E., E.O.R.

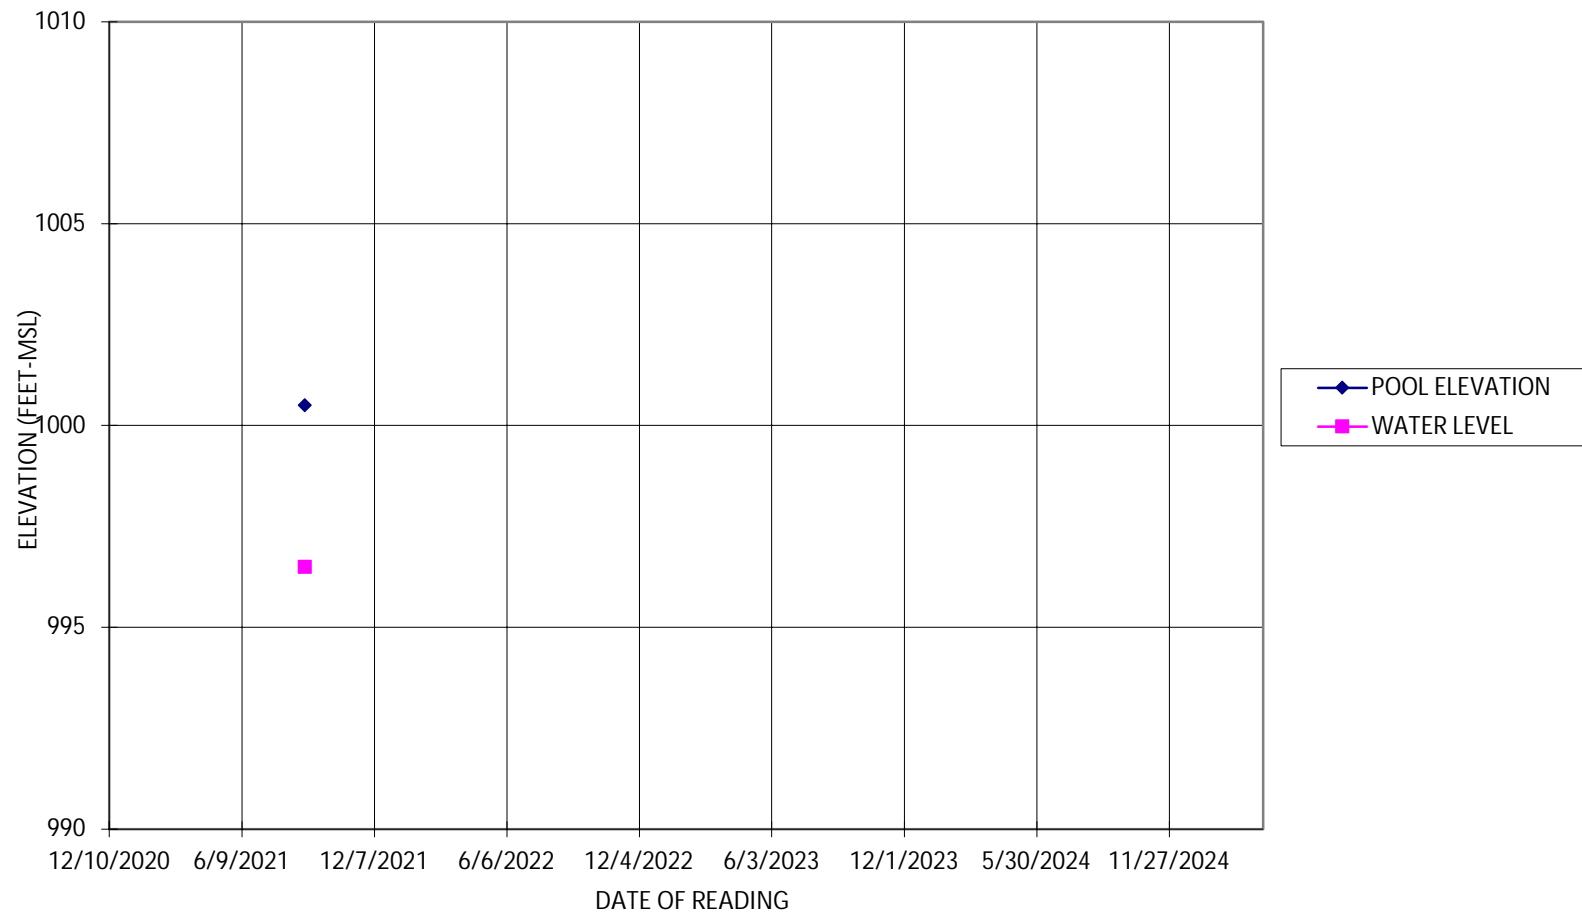
WELL NUMBER W-1

The downstream slope of the dam is covered with maintained vegetation that needs to be mowed. The slope appears to be approximately 3 horizontal on 1 vertical (3:1). No signs of sloughing or sinkholes were observed. The wet area which was observed to the right of the low-level drain outlet approximately 20 feet up the slope near the toe of the dam continues to be wet and soft indicating seepage. Monitoring wells have been installed at the crest of the dam and around the seepage area to monitor this area. This area should continue to be monitored closely for any significant changes. See the attached well readings for additional information.

1. Mow the crest, embankments, and toe areas of the dam.
2. Continue to monitor the observation wells to look for any noticeable changes in seepage through the dam.
3. Remove any vegetation in the emergency spillway.
4. Continue to monitor seepage coming through the cracks in the concrete chute emergency spillway.
